# A STEP BACK IN TIME

What were the factories like that led this expansion of the footwear industry from the late 1800s up to World War I? Very few of the original companies survive and, of those, hardly any have a complete photographic record of the time. One exception is Crockett & Jones, established in Northampton in 1879, still owned by the same family and still making shoes to the same high quality as when the company first started.

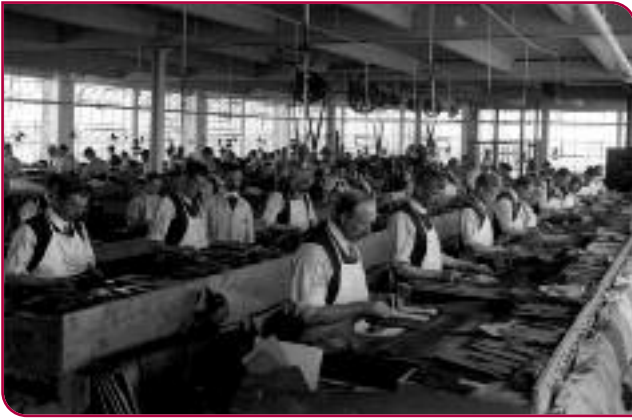
**Clicking:** Shoe factories at the end of the 19th century were built in the middle of towns. Land was at a premium so they were built several stories high. Clicking departments were traditionally on the top floor where the light was best, with closing on the next floor down, followed by lasting, welting, and making as more machines became involved and the weight on each floor level increased.

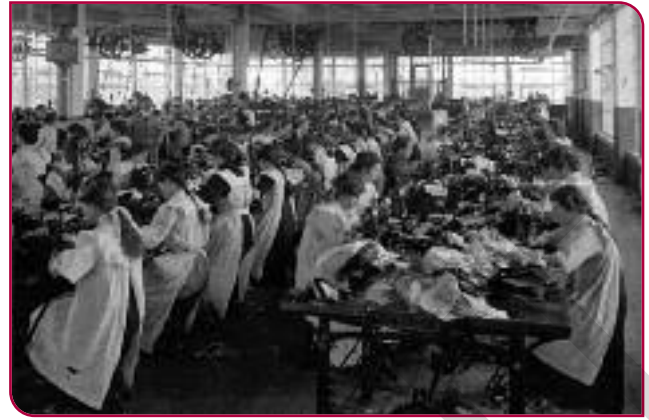
**Closing:** Sewing machines were driven by leather belts off a central shaft under the bench which was itself driven by either overhead shafting as in this instance or by an electric motor underneath. Note the absence of any guards on drive belts; health and safety was not a major consideration 100 years ago despite the long flowing dresses all women wore at the time.

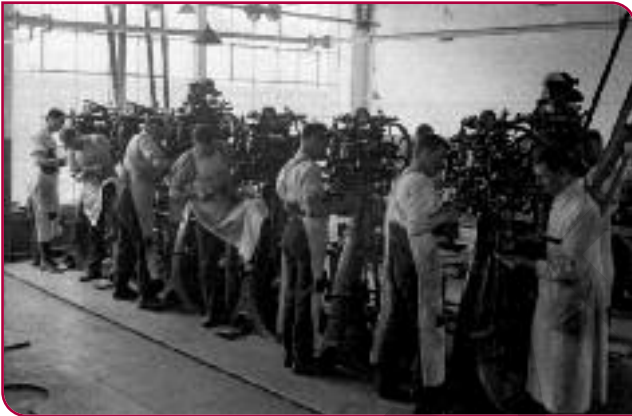
**Lasting:** After pulling-over, lasting for welted shoes would be performed on a hand operated flatbed machine using wiper plates and, for flat lasted constructions, a pincer machine which pulled and twisted the upper to form pleats as in hand lasting. The photo shows a row of the latter. They were hard work and operators soon gained upper body strength and a real 'shoemakers grip'.

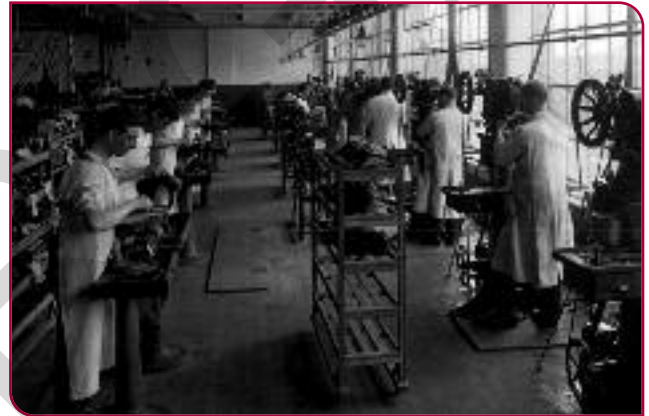
**Welting:** The welt sewers working on the right were key employees as the seam between welt and insole rib is the foundation of a welted shoe. While both they and the inseam trimmers further down the room are positioned to receive good light, the operators performing ancillary tasks had to make do with less. Work in progress was carried on wooden racks which were moved from floor to floor by a simple hand operated lift.

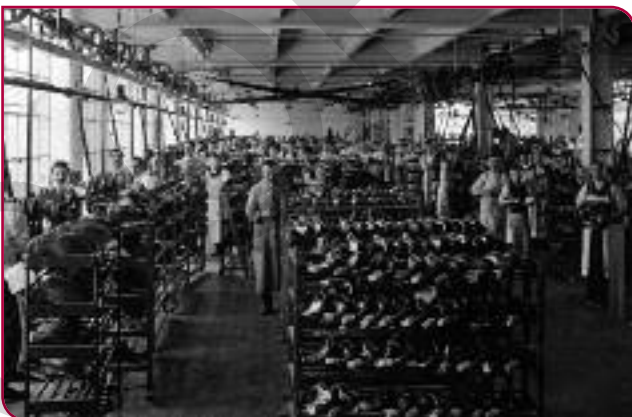
**Making:** Key operations such as rough rounding and outsole stitching (left) were located down each side against the windows with the centre of the room containing operations such as sole attaching, channel closing (front right), sole levelling and heel attaching. It was invariably crowded with racks waiting at each of a large number of separate operations. This in turn meant far more lasts were used than today but, at the same time, that shoes stayed on the last longer and this helped them to retain their shape.

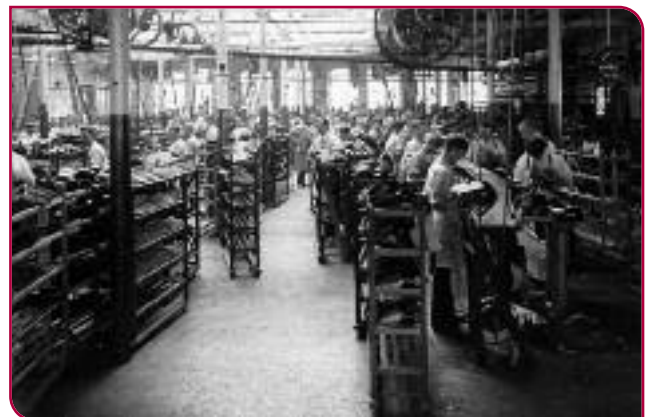
**Finishing:** This either formed a special section of the making department or was located on the ground floor so that racks of finished shoes could be wheeled straight into the shoe room and packing department. The finishers trimmed, scoured, waxed and edge set the soles and heels using a variety of machines all running at different speeds. Main line shafting only ran at a constant speed so the size of the shaft pulley for each machine had to be matched to the one on the later such that it ran at the correct speed.

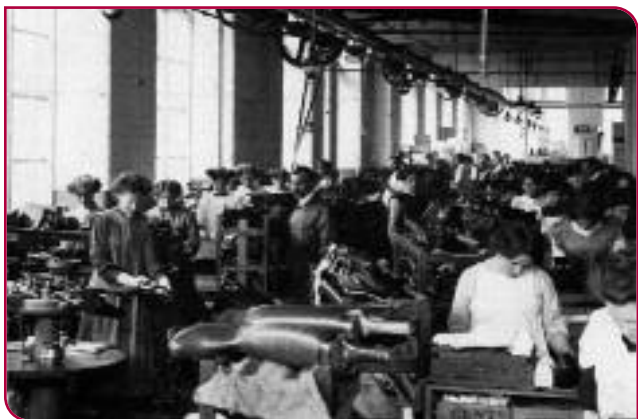
**Shoe Room:** In most modern factories, this would now be called the finishing department as completed shoes were cleaned, polished and inspected for quality. Most of this would have been carried out by hand much as it is today. Women in shoe factories were only employed as closers, in the shoe room and in the offices. Regardless of the department involved, supervisors were always men.

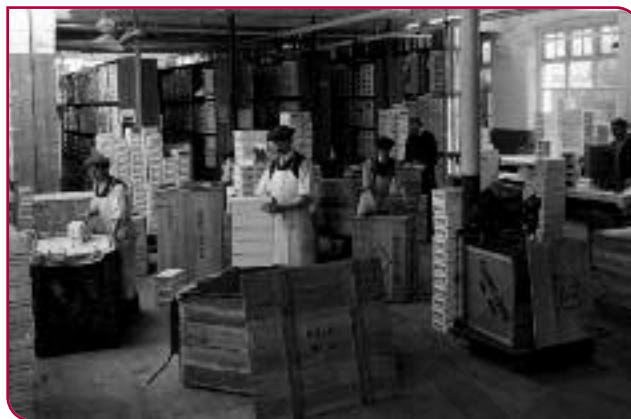
**Packing:** This view has been specially 'staged' to demonstrate the extent of the company's export trade, with Milan, Brussels, Buenos Ayres and Melbourne all visible on packing cases. The company was in fact awarded the Diploma of Honour at the 1911 International Manufacturing Exhibition in Turin. Note the staff all wearing caps.

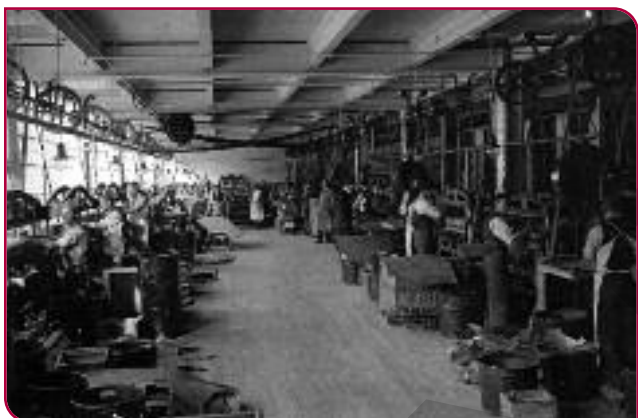
**Roughstuff:** As upper leather went in at the top of the building, soling leather went in at the bottom. Most factories cut and processed all bottom stock components themselves. As many of the machines were extremely heavy, the department was often located in a semi-basement area. The 'Revolution' cutting presses shown had a constantly turning flywheel which was tripped by a foot treadle to bring the beam down on to the forged steel cutting die which the operator held with both hands. While fast, they were also dangerous and operators often lost one or more fingers.

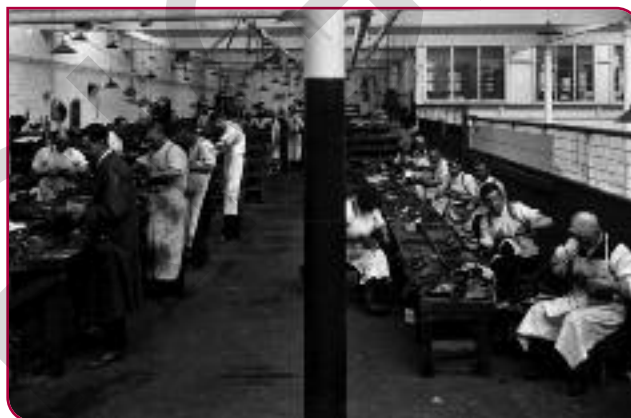
**Handsewn:** The very best welted shoes might have had both the welt and sole seams sewn by hand as the flatter insole rib produced a more flexible shoe than the machine welted version. Hand sewers needed no machines, just somewhere to sit and a tray to hold their tools as they held the lasted shoe down to their legs with a simple strap tensioned by one of their feet in the same manner as the old hand shoemakers (centre foreground). They could therefore be fitted in wherever there was a convenient area which, as can be seen here, was not necessarily the best that the factory had to offer.
